RADIOGRAPHER'S WELD INTERPRETATION
REFERENCE GUIDE

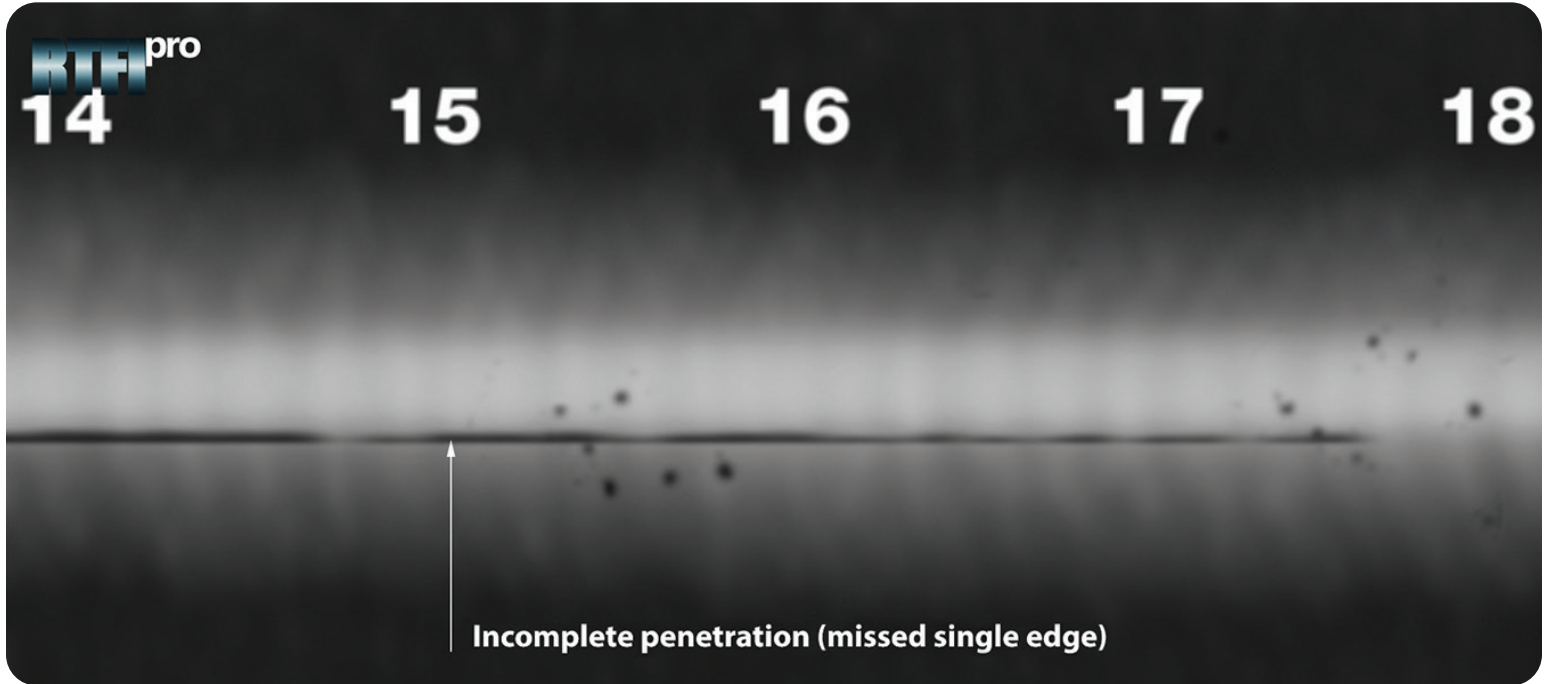
INCOMPLETE PENETRATION SINGLE EDGE

Also known as Lack of Penetration or Inadequate penetration, it is the region of incomplete filling of the weld root area on one side due to misalignment or no misalignment as in accordance with ASME enquiry 18-895. This Hi-lo version is classified inadequate penetration due to Hi-Lo for API 1104.

**Classified Incomplete penetration for ASME in accordance to ASME Enquiry 18-895, however for CSA Z662 it is considered Lack of fusion*

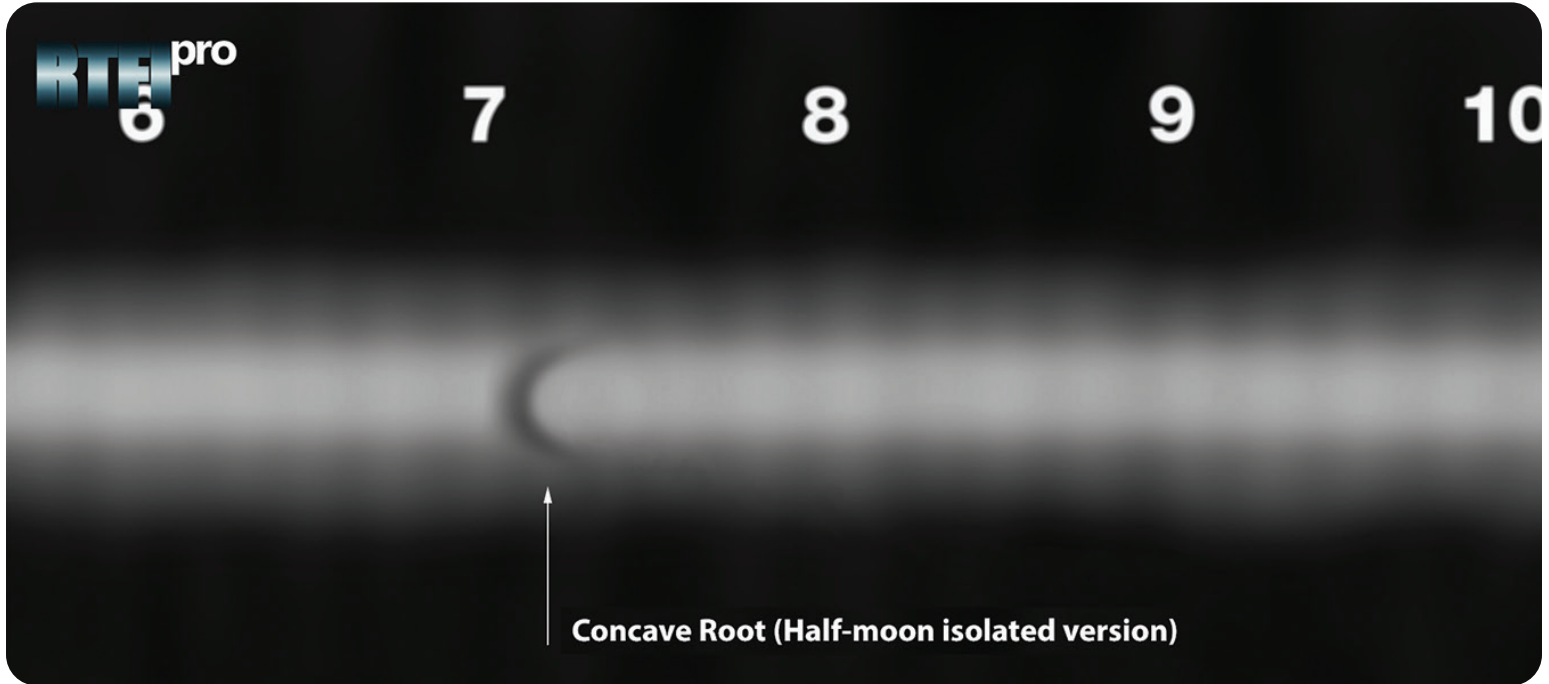
CONCAVE ROOT HALF MOON

Concave (Internal Concavity) is a concave condition in the root pass that results from insufficient heat input while depositing the root pass. It is sometimes referred to as “suck back”.

Unlike incomplete penetration, the root bead is fused to both surfaces and the center of the root pass is slightly concaved within. Unlike incomplete penetration the root is fused with internal concavity. With most codes the density must not be darker than the thinnest base metal.

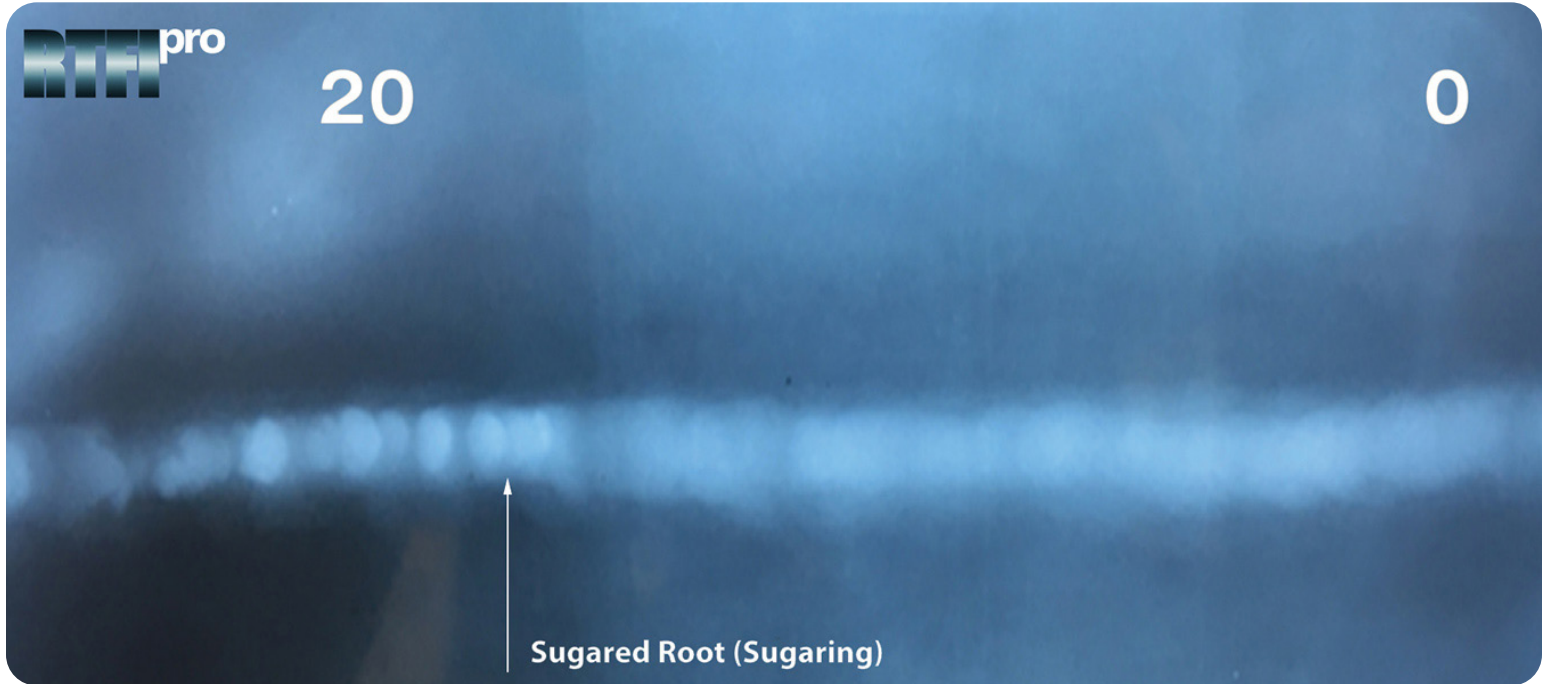
SUGARED ROOT

Sugared Root (or Sugaring) is the oxidation of stainless-steel welds caused due to the inadequate (or loss) of purging gas. It is also known as granulation due to its appearance as granular sugar. It is evaluated (and even rejected depending on the severity) on the basis of weld metal not flowing smoothly into the base metal.
